## Corrosion Control of Coated Structural Components in Marine Environment

G. L. Manjunath<sup>1</sup> S. Surendran<sup>2\*</sup>

1. Department of Ocean Engineering, Indian Institute of Technology Madras, Chennai, India

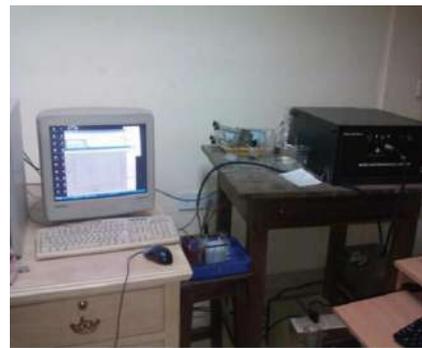
Figure 1. (a) Electro chemical set up

The figures 1 (a) and 1 (b) shows the cell set up along with arrangements for potentiodynamic polarization. In figures 1 (c) and 1 (d) the samples are corroded in 3.5% NaCl for 2400 hours and washed with distilled water thoroughly before seeing the weight of the corroded samples. Figure 1(e) showed how the sample is being corroded near notch and compared to other electroplated samples (on the right side) the PVD coated samples (to the left showed) more corrosion resistance. The 20µm electroplated samples of Cr sample to the right were better corrosion resistance compared to Ni samples to the left. Aluminum samples showed the phenomenon of deposition of salt on the surface. The salt is getting deposited on the surface of 6µm Ni coated aluminum samples. The removal of deposited salt from the surface can result in removal of the substrate. Comparatively, the coated samples are corroding fast compared to uncoated samples.

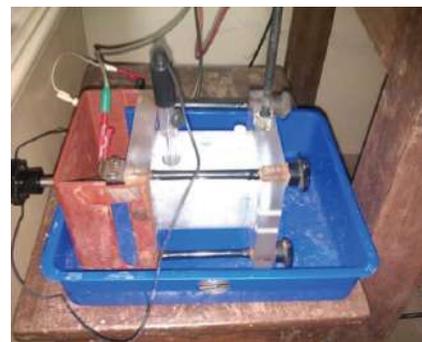
Figure 1. (b) Sample along with cell components

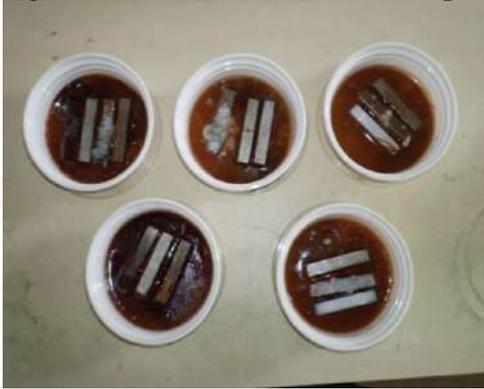
Figure 1. (c) Samples corroded in 3.5% NaCl

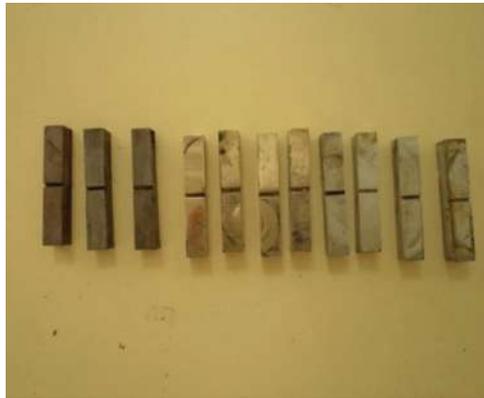
Figure 1. (d) Samples after corroding for 2400 hours

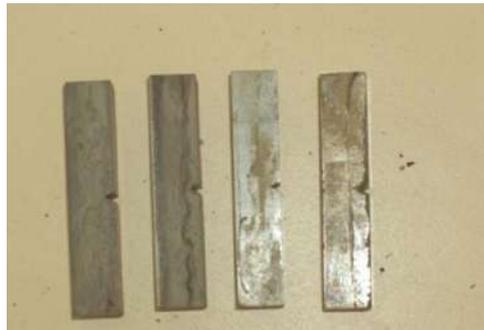
Figure 1. (e) 6µm Coated samples of PVD and electroplated samples corroded for 2400 hours

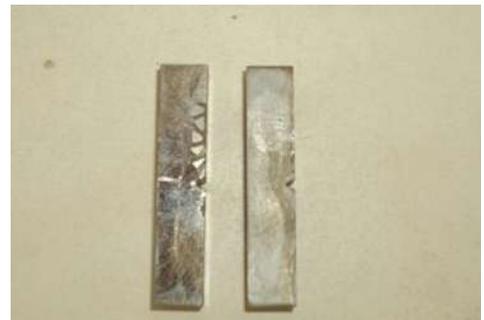
Figure 1. (f) 20µm Samples of Ni and Cr corroded for 2400 hours.

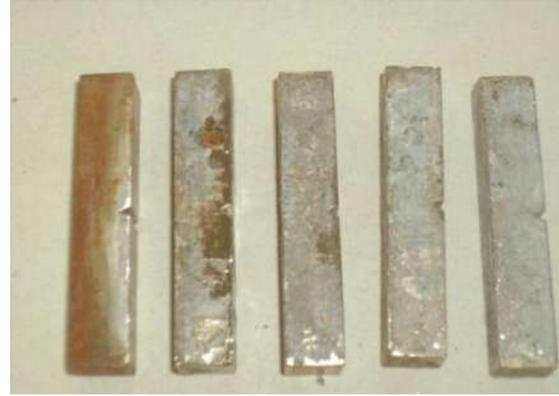
Figure 1. (g) from left to right: uncoated sample of aluminum, 6µm Ni coated aluminum, 20µm Ni coated aluminum, 40µm Ni coated aluminum and 60µm Ni coated aluminum after corroding for 2400 hours

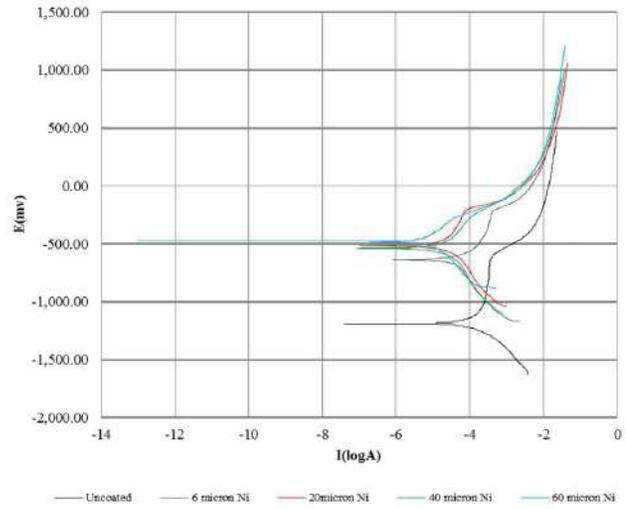
The uniform and pitting corrosion tests were conducted to study the corrosion effect on crack growth due to cyclic loading responsible for the catastrophic failure of the structure. In pitting growth, a pit can cause the growth of other micro pits around it leading to multiple cracks. The phenomenon of multiple cracking is assumed in uniformly and pitting corroded samples individually due to corrosion. Both uniform and pitting corrosion is considered together for samples by assuming uniform corrosion to occur first followed by pit formation. To overcome the above problems a technique of coating is adopted in the present work; coating helps to reduce the corrosion rate thus enhancing the life of the structure. Selection of coating material depends on adhesive strength and depends on the ability towards corrosion. The permeability in coating decides the durability and transition temperature of the coating. Potentiodynamic tests on electroplated Ni aluminum samples showed the increase in corrosion resistance with an increase in coating thickness as per figure 2. The coated and uncoated samples of aluminum were tested

in 3.5% NaCl, and NaOH added to maintain the pH. The formation of pits can be seen in almost every coated and uncoated samples of aluminum.

Figure 2.  $E_{\text{corr}}$  Vs.  $I_{\text{corr}}$  for coated and uncoated aluminum samples

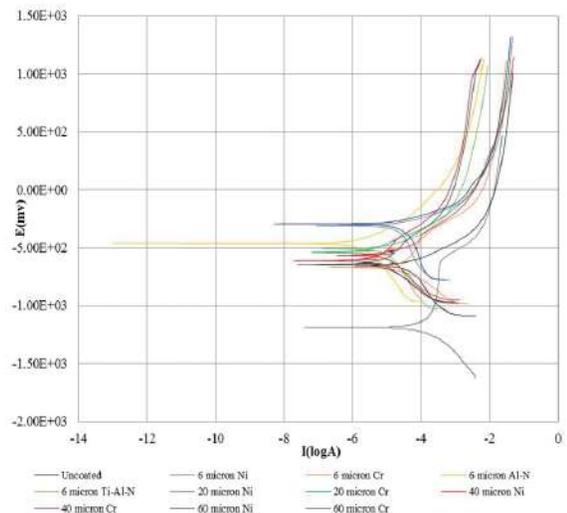
The potentiodynamic polarization of electroplated steel samples showed an increase in corrosion resistance with an increase in coating thickness. Electroplated Ni samples of steel showed the formation of pits in all the coated samples with coating thickness varying from  $6\mu$ ,  $20\mu$ ,  $40\mu$  and  $60\mu$  shown in figure 3. In Cr electroplated samples of steel, pits are observed in  $6\mu$ ,  $20\mu$  and  $40\mu$  samples except in  $60\mu$  case. When the PVD coated samples were tested, the  $6\mu$  Al-N steel coated sample showed a slight wearing out of the surface due to corrosion, and in  $6\mu$  Ti-Al-N no such phenomena were seen thus was a case of excellent corrosion resistance.

Figure 3.  $E_{\text{corr}}$  Vs.  $I_{\text{corr}}$  for coated and uncoated steel samples

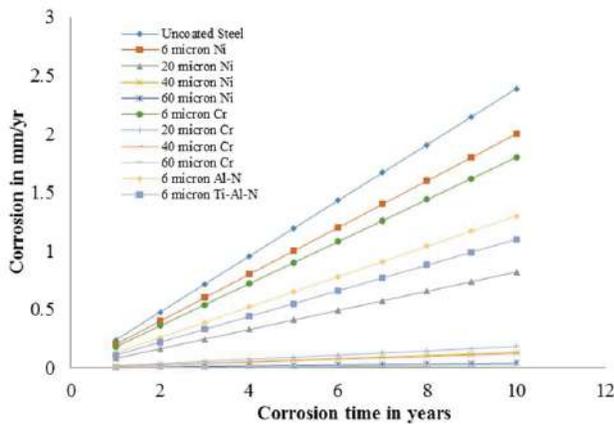
After the weight loss experiment, the corrosion rate against corrosion time was plotted for uniform corrosion of both coated and uncoated samples. Parent metals of steel and aluminum were considered, and equation two was relied upon. In the case of Ni and Cr electroplated steel samples the increase in coating thickness reduced the corrosion rate and in PVD coated Al-N and nano crystalline Ti-Al-N steel samples was found to be still shown in figure 4. In Ni electroplated sample of aluminum the salt started to deposit on the 6 $\mu$  Ni coated samples. No salt deposition was observed in uncoated samples of aluminum. Removing the deposition of salt from samples in 6 $\mu$  Ni coated samples resulted in the removal of substrate material. For aluminum this is equivalent to an increase of corrosion rate.

Figure 4. corrosion rates against corrosion time for uniformly corroded steel samples

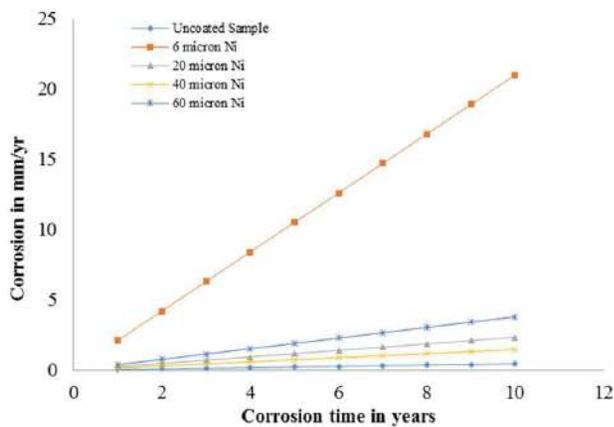
Figure 5. Corrosion rates against corrosion time for uniformly corroded aluminum samples

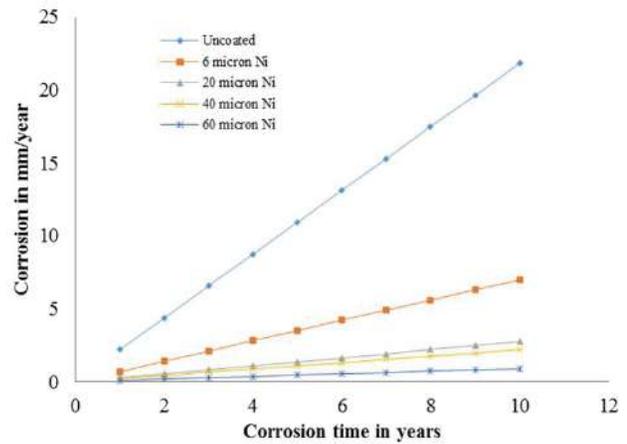
As per the potentiodynamic polarization, the pitting corrosion rate against time is reduced due to an increase in coating thickness. For coated and uncoated steel and aluminum samples a comparison of figure 6 and seven will easily convince this.

Figure 6. Corrosion rates against corrosion time for pitting corroded aluminum samples

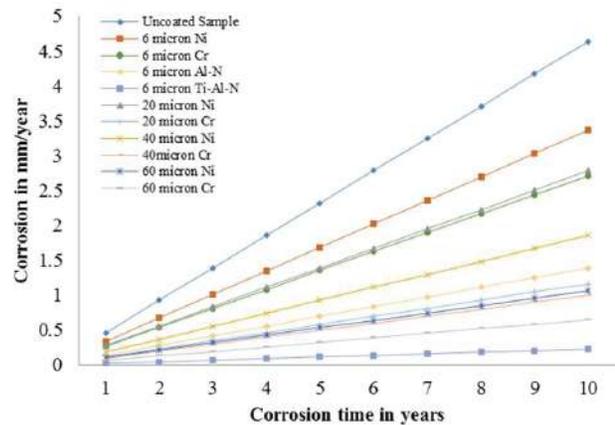
Figure 7. Corrosion rates against corrosion time for pitting corroded steel samples

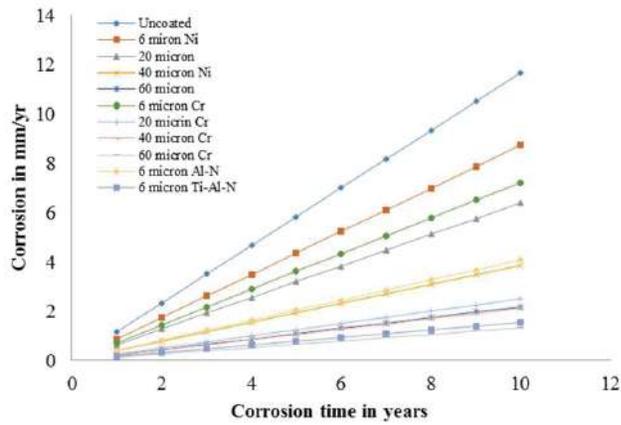
Different combinations of corrosion rates, pitting and uniform corrosion are considered by deducting the thickness from the sample. The increase in thickness shows an increase in corrosion rate and reduced performance of the structural components. The corrosion rate against corrosion time is plotted considering the combination is shown in figure 8 and figure 9 for steel and aluminum. The steel samples showed an increase in corrosion rate compared to aluminum shown in figure 8 and 9. The influence of coating thickness on corrosion is proved here, through not directly. Classification societies insist on the renewal of plates, stiffness and structural part based on the diminishing of thickness on a percentage basis. It varies from location to location on ship hull contour.

**Figure 8.** Corrosion rates against corrosion time for pitting and uniformly corroded steel samples

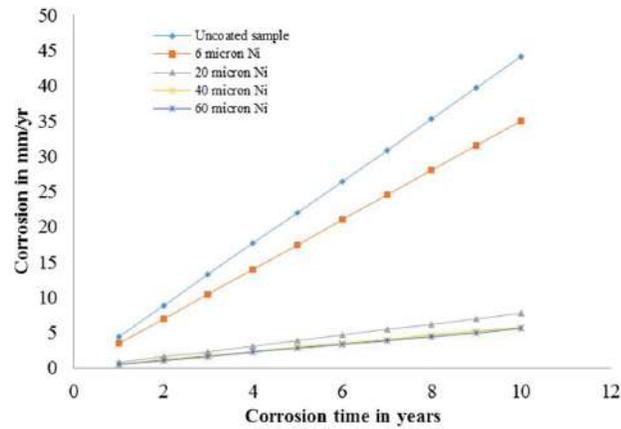
**Figure 9.** Corrosion rates against corrosion time for pitting and uniformly corroded aluminum samples

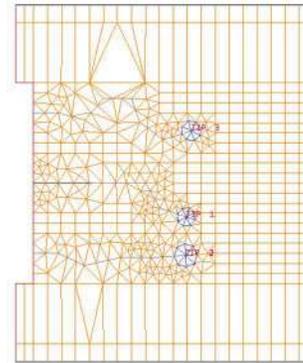
toughness due to the diminishing of thickness due to corrosion. The simulation was done by FRANC 2D/L, and the corresponding  $K_{\text{effective}}$  against crack lengths were calculated for uniform and pitting corrosion initially, and later both were combined.  $K_{\text{effective}}$  against crack lengths is calculated for 1 and five years respectively for coated and uncoated samples of steel and aluminum.  $K_{\text{effective}}$  values found increasing with increase in corrosion time for uncoated samples. Coated steel samples showed a decrease in  $K_{\text{effective}}$  with an increase in coating thickness in case of an electroplated sample of steel from figures 11 and 12. In figures 11 the value of  $K_{\text{effective}}$  is found less compared to figures 12 in which the  $K_{\text{effective}}$  is found increasing due to increasing in corrosion rate. The Al-N and Ti-Al-N samples showed corrosion resistance with coating not getting peeled off near the notch, while in electroplated samples peeling of coating near the notch can be observed in case of steel samples. Multiple cracks were grown near the uniformly corroded area and crack with high  $K_{\text{effective}}$  was

considered for the analysis. The reduction in thickness of sample will affect the  $K_{\text{effective}}$  values and even cause a grouping of cracks.

**Figure 10.** Crack growth for uniformly corroded samples

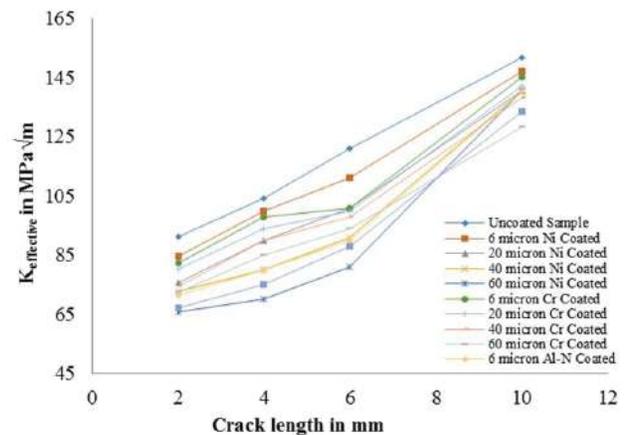
**Figure 11.**  $K_{\text{effective}}$  against crack length for one year uniformly corroded steel samples

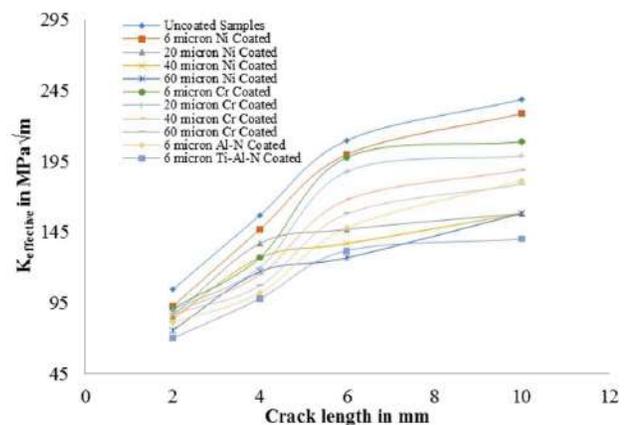
**Figure 12.**  $K_{\text{effective}}$  against crack length for five year uniformly corroded aluminum samples

Figure 12 clearly explains that the increase in coating increased the corrosion resistance and indirectly reduced the  $K_{\text{effective}}$  values. Particularly the 60 $\mu$  coated samples

and 6µ PVD coated samples showed almost linear variations. But in the case of other uncoated and electroplated samples, a nonlinear behavior can be observed in 6µ, 20µ and 40µ samples from figure 12. The 6 Cr coated case is showing a higher order nonlinearity of stress intensity factor. The above corrosion calculations are considered in the simulation, and different cracks are grown at different regions as per figure 13. The occurrence of the first crack can influence the behavior of the other two cracks. Figure 13 also illustrates that the crack may either cut each other or the stress radiated from one crack can cause the deflection of the nearby crack.

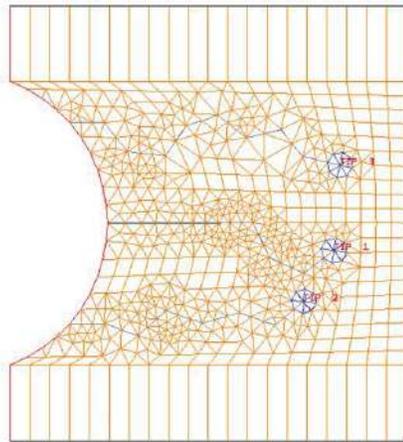
Figure 13. Crack growth for pitting corroded samples

The pitting corrosion results showed a decrease in  $K_{\text{effective}}$  for PVD coated samples compared to electroplated samples. In pitting the  $K_{\text{effective}}$  is found high compared to uniform corroded samples because of stress concentration at the pits formed. The pits formed can cause the growth of one or more cracks which may grow under the cyclic loading and corrosive environment in order to simulate this condition, multiple cracks as assumed near the pits to study the influence of pits and crack with high  $K_{\text{effective}}$ . Figure 14 shows a highly nonlinear behavior for uncoated and 60µ Ni electroplated samples compared to other examples the trend of which are almost linear. The increase coating thickness may lead to peeling off coating in electroplated samples.

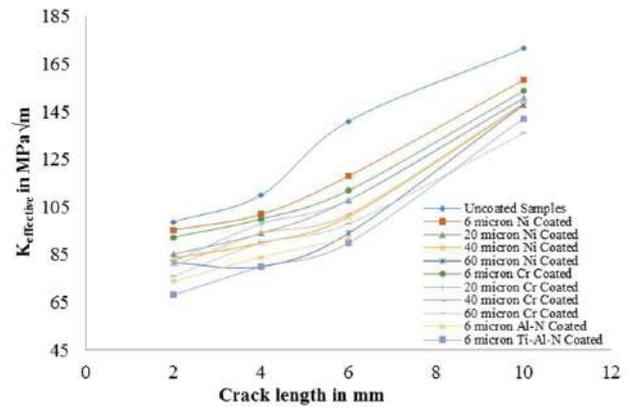
Figure 14.  $K_{\text{effective}}$  against crack length for one year pitting corroded steel samples

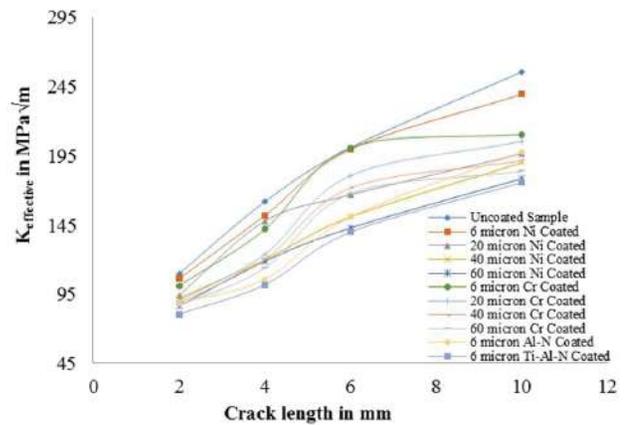
In figure 15 an increase in the corrosion rate influenced the crack kinking and hence more  $K_{\text{effective}}$  values. More importantly with an increase in crack length at around 6mm a severe shift in the values of  $K_{\text{effective}}$  can be observed. The PVD coated samples and those with higher coating thickness showed a linear variation after a crack length of 6mm. As expected a lesser value of  $K_{\text{effective}}$  are seen in figure 15. It can be inferred that the method of coating effects the adherence properties of the substrates and influences the corrosion resistance properties.

Figure 15.  $K_{\text{effective}}$  against crack length for five year pitting corroded steel samples

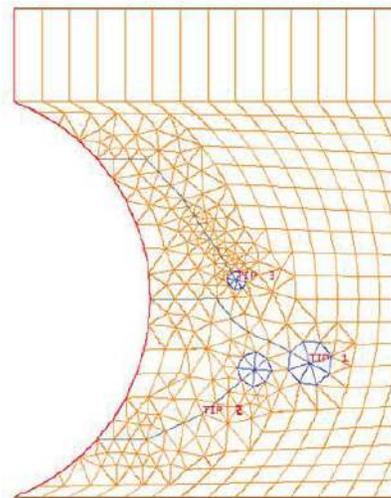
Figure 16. Crack growth for uniformly and pitting corroded samples.

The pitting and uniform corrosion are combined, and simulation was carried shown in figure 16 and figure 17. As per figure 16, when the multiple cracks were grown,

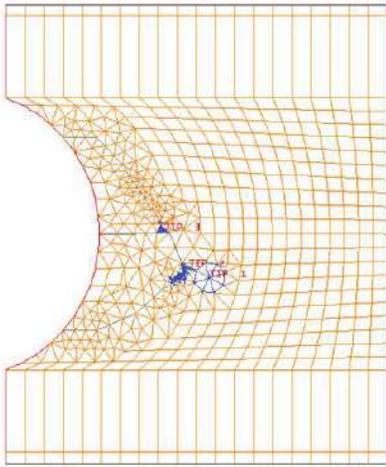
Figure 17. Crossing of one crack on the other

two or three cracks are seen to be meeting. It is observed in figure 17 that the two cracks followed upon their meeting, lead to chipping of part of the substrate and leading to failure of the entire structural component.

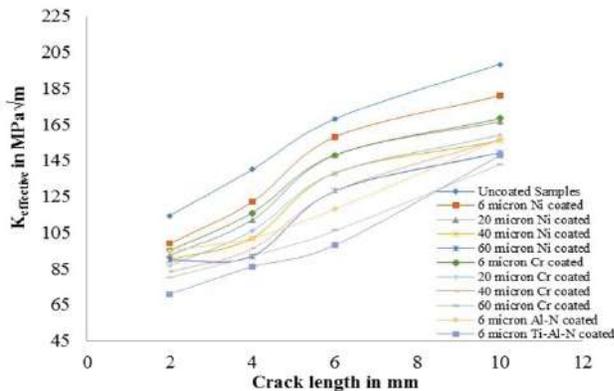
In figure 18, the combination of pitting and uniform corrosion together increased the  $K_{\text{effective}}$  values compared to the total effect of uniform and pitting corrosion separately. The same phenomenon of PVD and higher coating thickness samples show a linear behavior in  $K_{\text{effective}}$  values with increase in crack length. Other samples showed a nonlinear behavior as shown in figure 18.

Figure 18.  $K_{\text{effective}}$  against crack length for one year pitting and uniformly corroded steel samples

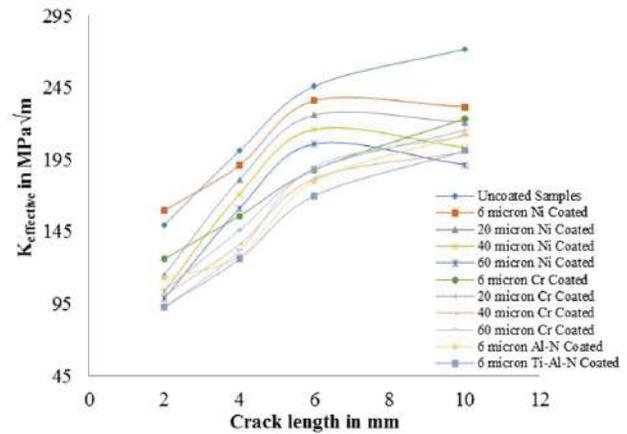
Increase in corrosion rate leads to more reduction in thickness of samples in combined corrosion phenomenon from figure 19. A rise in  $K_{\text{effective}}$  values can be found because of the combined corrosion phenomenon. The PVD and higher coating thickness samples showed almost non-linear behavior. In case of other coated samples showed a highly nonlinear behavior at 6mm crack length and 10mm crack length. The kinking of crack is drastic with a reduction in thickness, and  $K_{\text{effective}}$  values are affected, and the

same is illustrated using figure 19.

Figure 19.  $K_{\text{effective}}$  against crack length for five year pitting and uniformly corroded steel samples

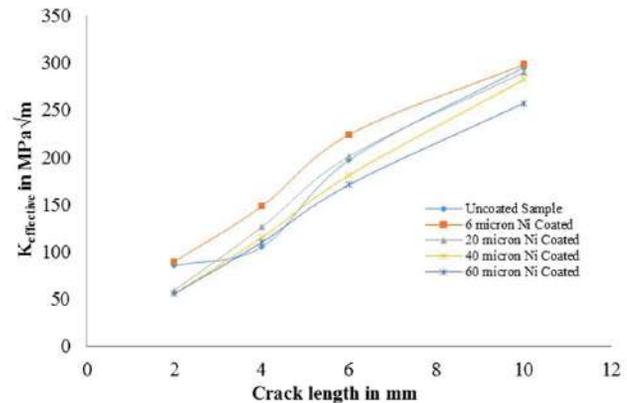
In the case of electroplated aluminum samples, the behavior of  $K_{\text{effective}}$  values was different from figure 20. Compared to uncoated and higher coating thickness samples the 6μ Ni coated samples showed increased  $K_{\text{effective}}$  values because of reduction in thickness. The coated samples showed a linear behavior compared to uncoated cases which are showing highly nonlinear and is as observed in figure 20.

Figure 20.  $K_{\text{effective}}$  against crack length for one year uniformly corroded aluminum samples

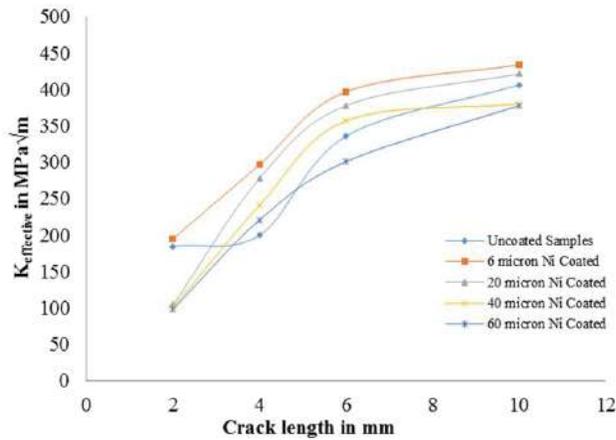
Further increase in corrosion rate result increased the  $K_{\text{effective}}$  values as per figure 21. The uncoated samples showed a highly nonlinear behavior with a drastic increase in  $K_{\text{effective}}$  values with increase in crack length. Other samples showed almost a linear behavior except 6μ Ni coated samples showed high  $K_{\text{effective}}$  values.

Figure 21.  $K_{\text{effective}}$  against crack length for five year uniformly corroded aluminum samples

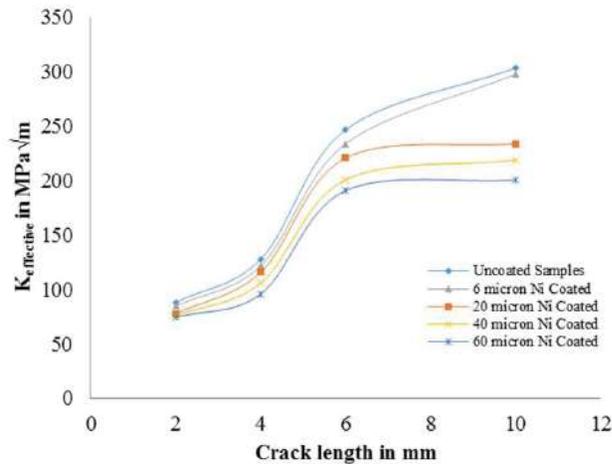
As for the pitting corrosion of aluminum coated samples, there is increase in corrosion resistance due to the increase in coating thickness. It is shown in figure 22. All the coated and uncoated samples showed a drastic in-

crease  $K_{\text{effective}}$  values with increase in crack length.

Figure 22.  $K_{\text{effective}}$  against crack length for one year pitting corroded aluminum samples

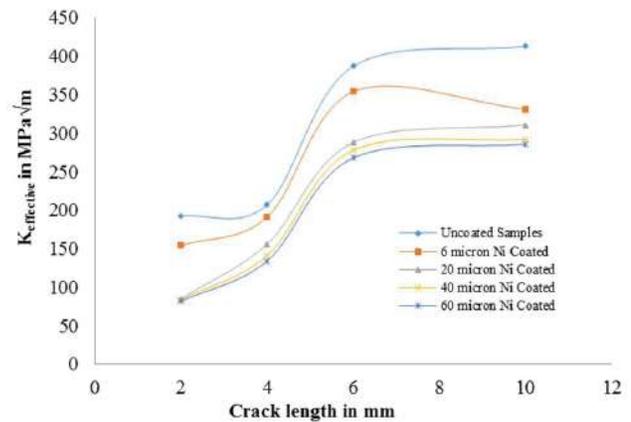
Figure 23 shows that an increase in corrosion rate will raise the  $K_{\text{effective}}$  values. A sudden rise in  $K_{\text{effective}}$  values can be observed in figure 23 near or around a crack length of 6mm. When the pit depth is increased, and stress around are also increased and with the introduction of crack the  $K_{\text{effective}}$  values are shooting up as per figure 23.

Figure 23.  $K_{\text{effective}}$  against crack length for five year pitting corroded aluminum samples

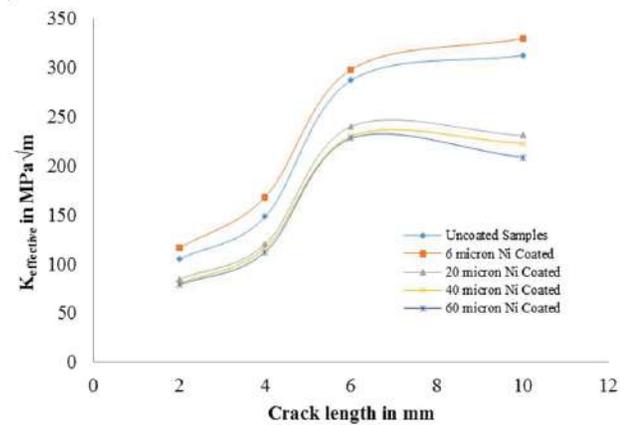
In the combined case of pitting and uniform corrosion, the case of 6 $\mu$  Ni coated samples showed an increase in  $K_{\text{effective}}$  values and is shown in figure 24. Compared to pitting corrosion the uniform corrosion is dominating in corrosion rate by causing the reduction in thickness.

Therefore, compared to other samples the 6 $\mu$  Ni coated samples shows an increased  $K_{\text{effective}}$  values along with an increase in corrosion rate.

Figure 24.  $K_{\text{effective}}$  against crack length for one year pitting and uniformly corroded aluminum samples

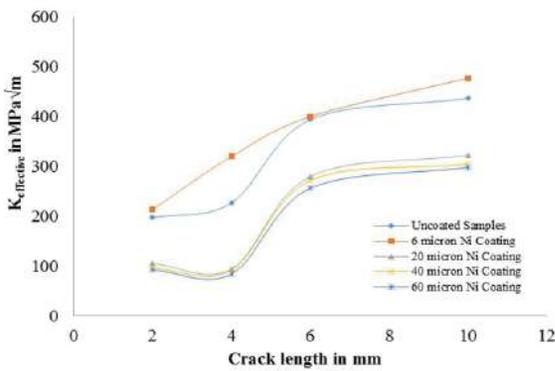
Figure 25 shows an increase in corrosion rate triggering a drastic increase in  $K_{\text{effective}}$  values. The 6 $\mu$  Ni coated samples showed a linear increase of  $K_{\text{effective}}$  values with increase crack length. The uncoated samples and higher coating thickness samples showed a nonlinear behavior at 4mm and 6mm crack length. The pitting depth is influencing the behavior at a certain crack lengths and is shown in figure 25.

**Figure 25.**  $K_{\text{effective}}$  against crack length for five years pitting and uniformly corroded aluminum samples

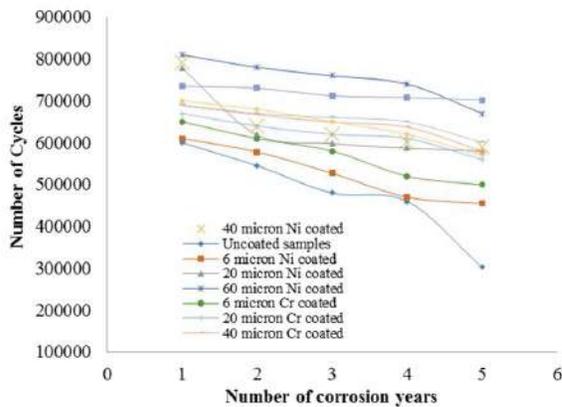
Fatigue analysis was performed for estimating the number of cycles against corrosion years for coated and uncoated samples of steel and aluminum. The analysis was performed by considering the effects of uniform, pitting and uniform and pitting together through figures 26-31. Figure 26 shows a number of cycles for different coated components, from the figure the uncoated samples shows a less number of cycles. The increase in coating thickness increased the corrosion resistance and increased the number of cycles.

**Figure 26.** Number of cycles against corrosion years for uniformly corroded steel samples

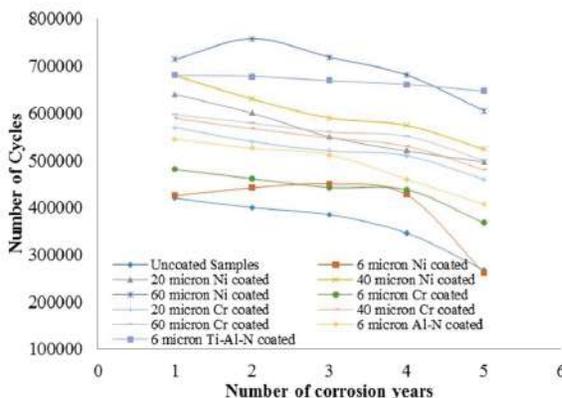
In pitting corrosion even though the uncoated samples showed less number of cycles, other coated samples showed a different behaviors. The number cycles decreased with increase in corrosion years, but 6 $\mu$  and 60 $\mu$  Ni coated samples showed a different behavior with increasing the number of cycles at certain and then reducing as per figure 27.

**Figure 27.** Number of cycles against corrosion years for pitting corroded steel samples

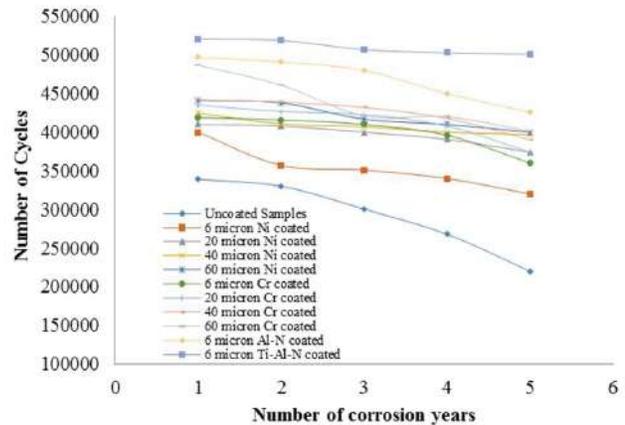
In figure 28 the combined corrosion phenomenon showed a decreased number of cycles with the increase in corrosion years. The 60 $\mu$  Cr coated samples showed a reduction in a number of cycles for a three year duration of corrosion. Although increase in coating thickness increases the corrosion resistance, there is a decrease in the coating toughness and the number of cycles.

**Figure 28.** Number of cycles against corrosion years for pitting and uniformly corroded steel samples

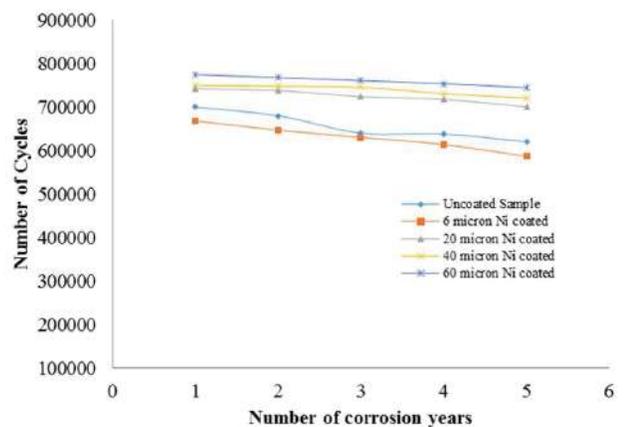
For aluminium coated samples, there is increase in a number of cycles for an increase in coating thickness except for 6 $\mu$  Ni coated samples as per figure 29. The increase in corrosion rate on the 6 $\mu$  Ni coated samples result in reducing the number of cycles.

**Figure 29.** Number of cycles against corrosion years for uniformly corroded aluminium samples

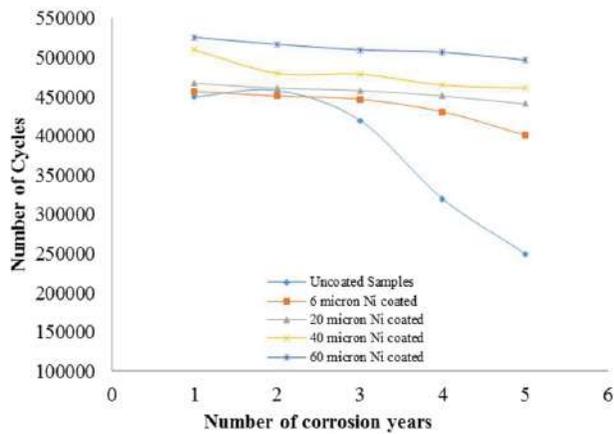
In the case of pitting corrosion of aluminum samples, the uncoated sample showed an increase in a number of cycles and again decreased from figure 30. The pit depth is effecting the performance of the crack, and the number of cycles is found diminished.

**Figure 30.** Number of cycles against corrosion years for pitting corroded steel samples

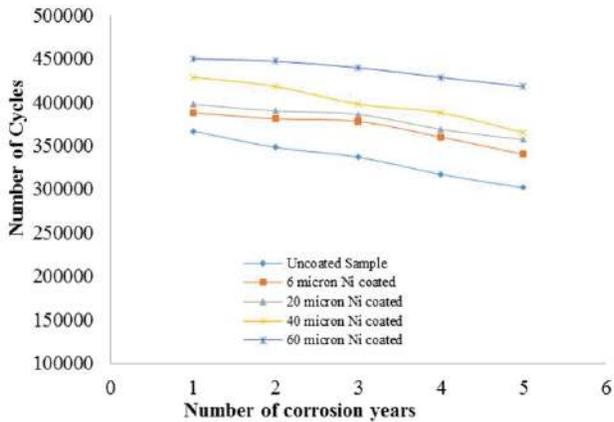
The combined effect of corrosion on aluminum coated samples did not affect much on coated samples as per figure 31. The increase in coating thickness increased the corrosion resistance and increased the number of cycles.

**Figure 31.** Number of cycles against corrosion years for pitting and uniformly corroded aluminum samples

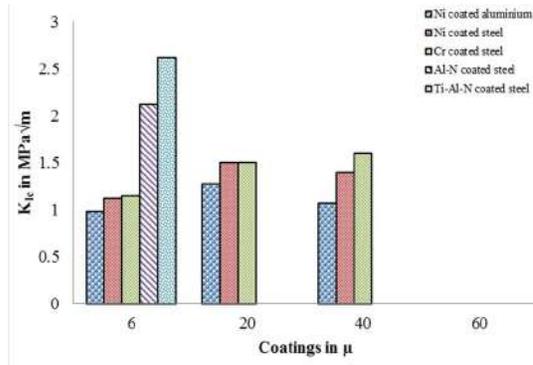
**Figure 36.**  $K_{Ic}$  against coating thickness for uncorroded steel and aluminum

Later the indentation near the pitting was conducted and found that a decrease in fracture toughness with an increase of some cracks. It is shown in figure 36. The increase in some cracks was due to micro pits formed around the main pitted area. Comparatively, Cr coated samples showed less number of cracks due to an increase in corrosion resistance as per figure 37.

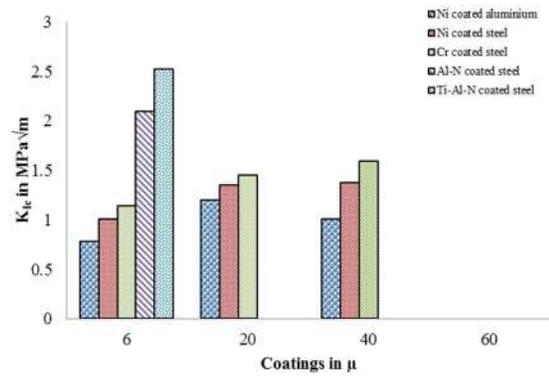
**Figure 39.**  $K_{Ic}$  against coating thickness for uncorroded steel and aluminum

Figure 39 shows higher fracture toughness values are seen for PVD coated samples compared to electroplated Ni and Cr samples.
